DNA-TR-90-72-V3

**Exposure of Air Breathing Engines to Nuclear Dust  
Environment (U)  
Volume III—Performance Deterioration of a Second F100  
Turbofan Engine Upon Exposure to a Simulated Nuclear  
Dust Environment (U)**

Michael G. Dunn  
Calspan Corporation  
P.O. Box 400  
Buffalo, NY 14225

January 1991

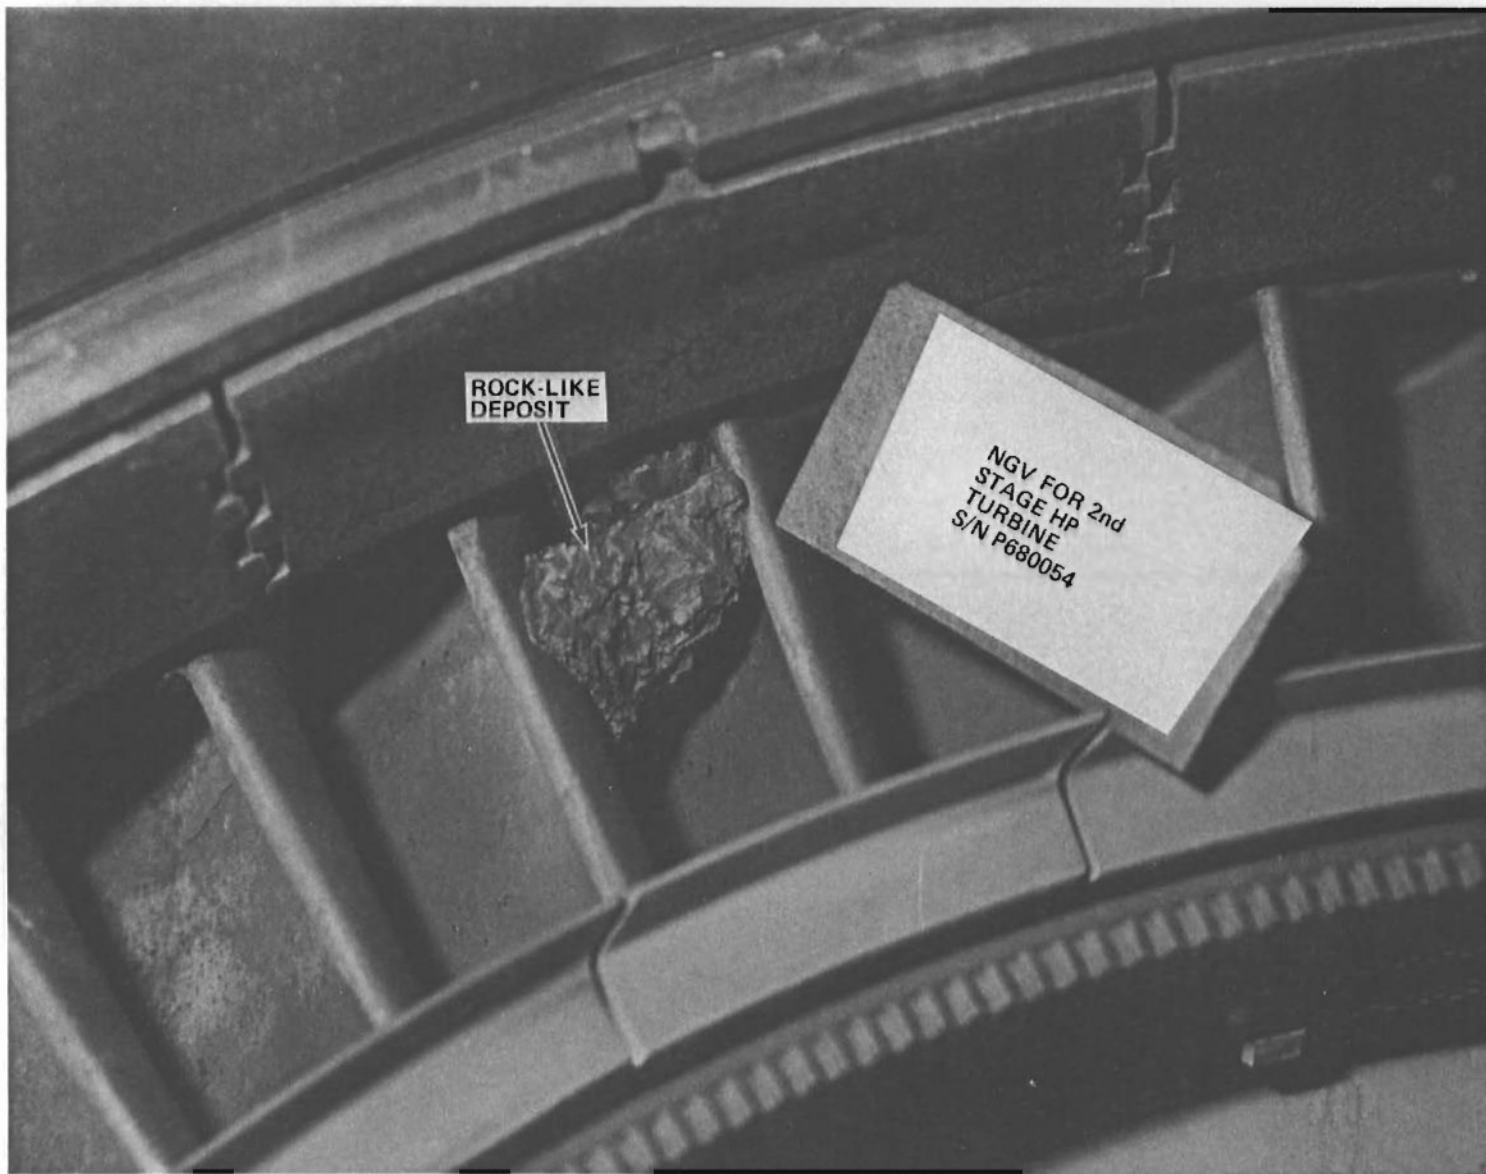
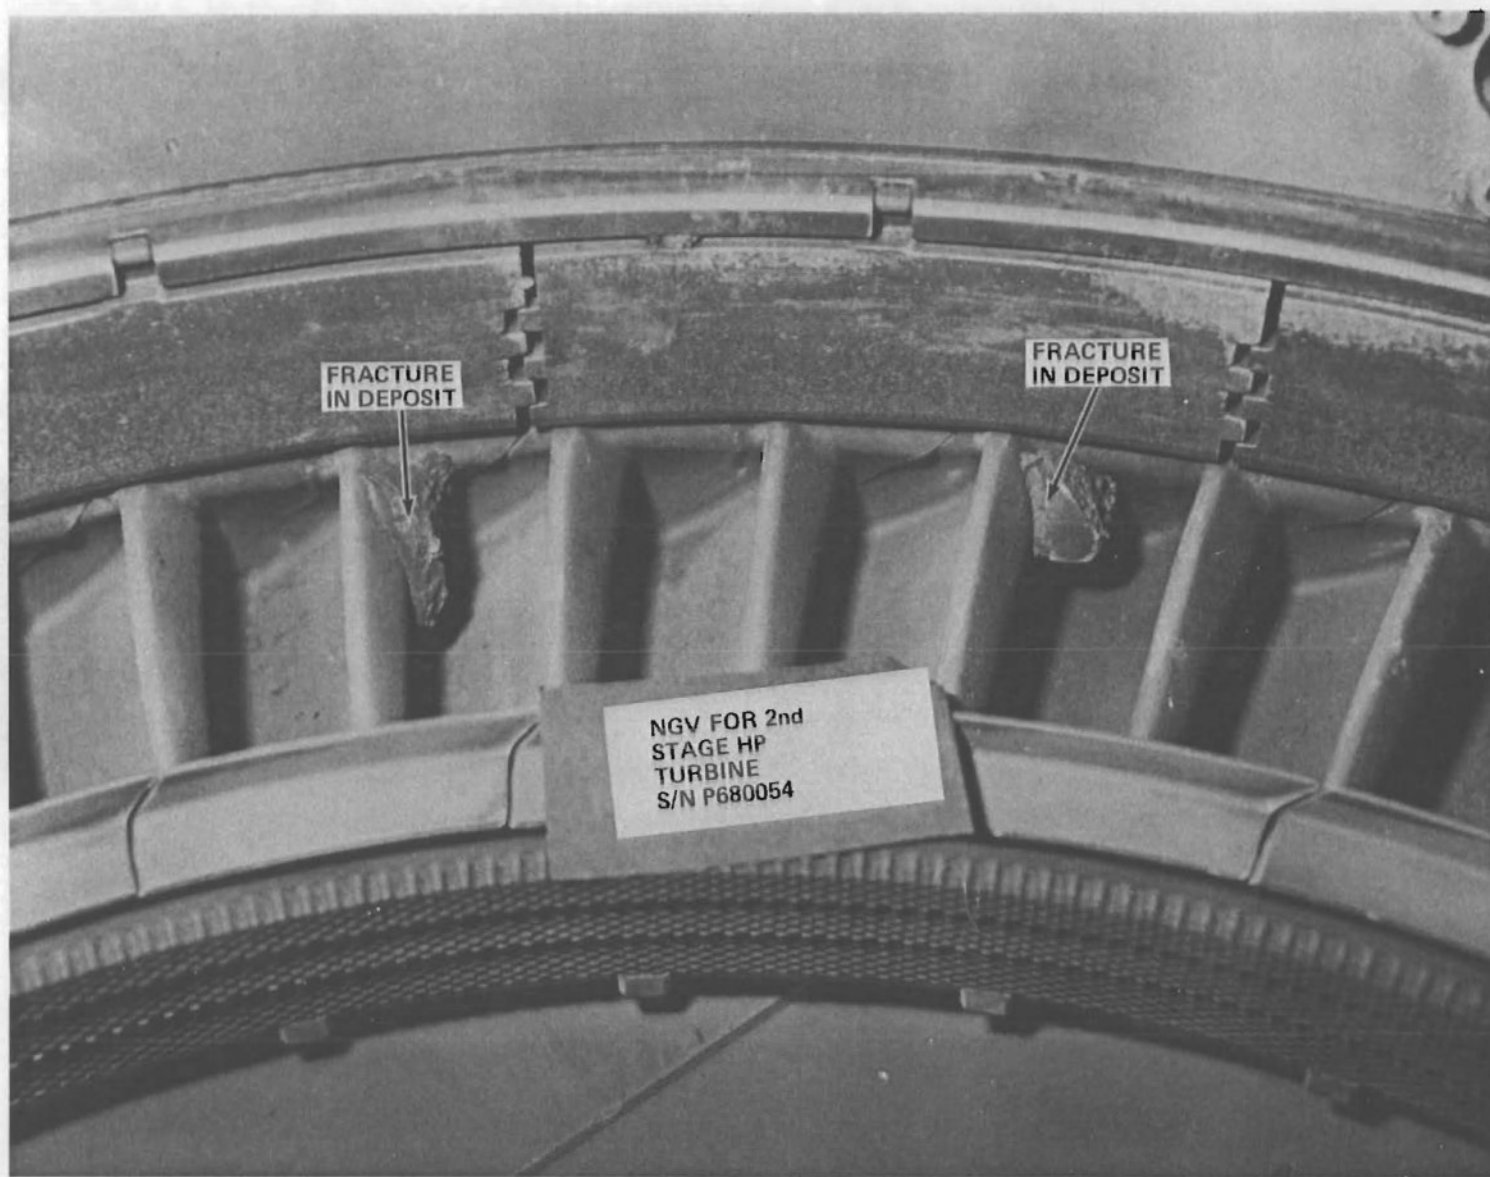
None of the low-pressure turbine (LPT) stages showed anything unusual. The brownish discoloration was the same as seen on the previous F100 engine. There were neither deposits on nor erosion of the LPT components. Nothing of any significance was seen until the teardown reached the nozzle guide vane row for the second stage of the high pressure turbine. Figures 17 and 18 are photographs of material found in this vane row. Figure 17 shows one of these pieces of material which was found to be very hard (rock-like) and blocked about 40% of the particular flow passage. Figure 18 is another photograph taken of the NGV for second stage high-pressure turbine showing two other deposits. These deposits were also very hard. Neither of them blocked as large a portion of the passage as did the deposit shown in the previous photograph, but perhaps that is because the deposits appear from the photograph to have fractured. Several very hard pieces similar to those shown in Figures 17 and 18 were found in the combustor liner, the implication of this is that they were blown forward in the engine during the multiple surge event described in Section 3.5.

Figure 17. (U) Photograph of nozzle guide vane for second stage high-pressure turbine.

Figure 18. (U) Photograph of nozzle guide vane for second stage high-pressure turbine.

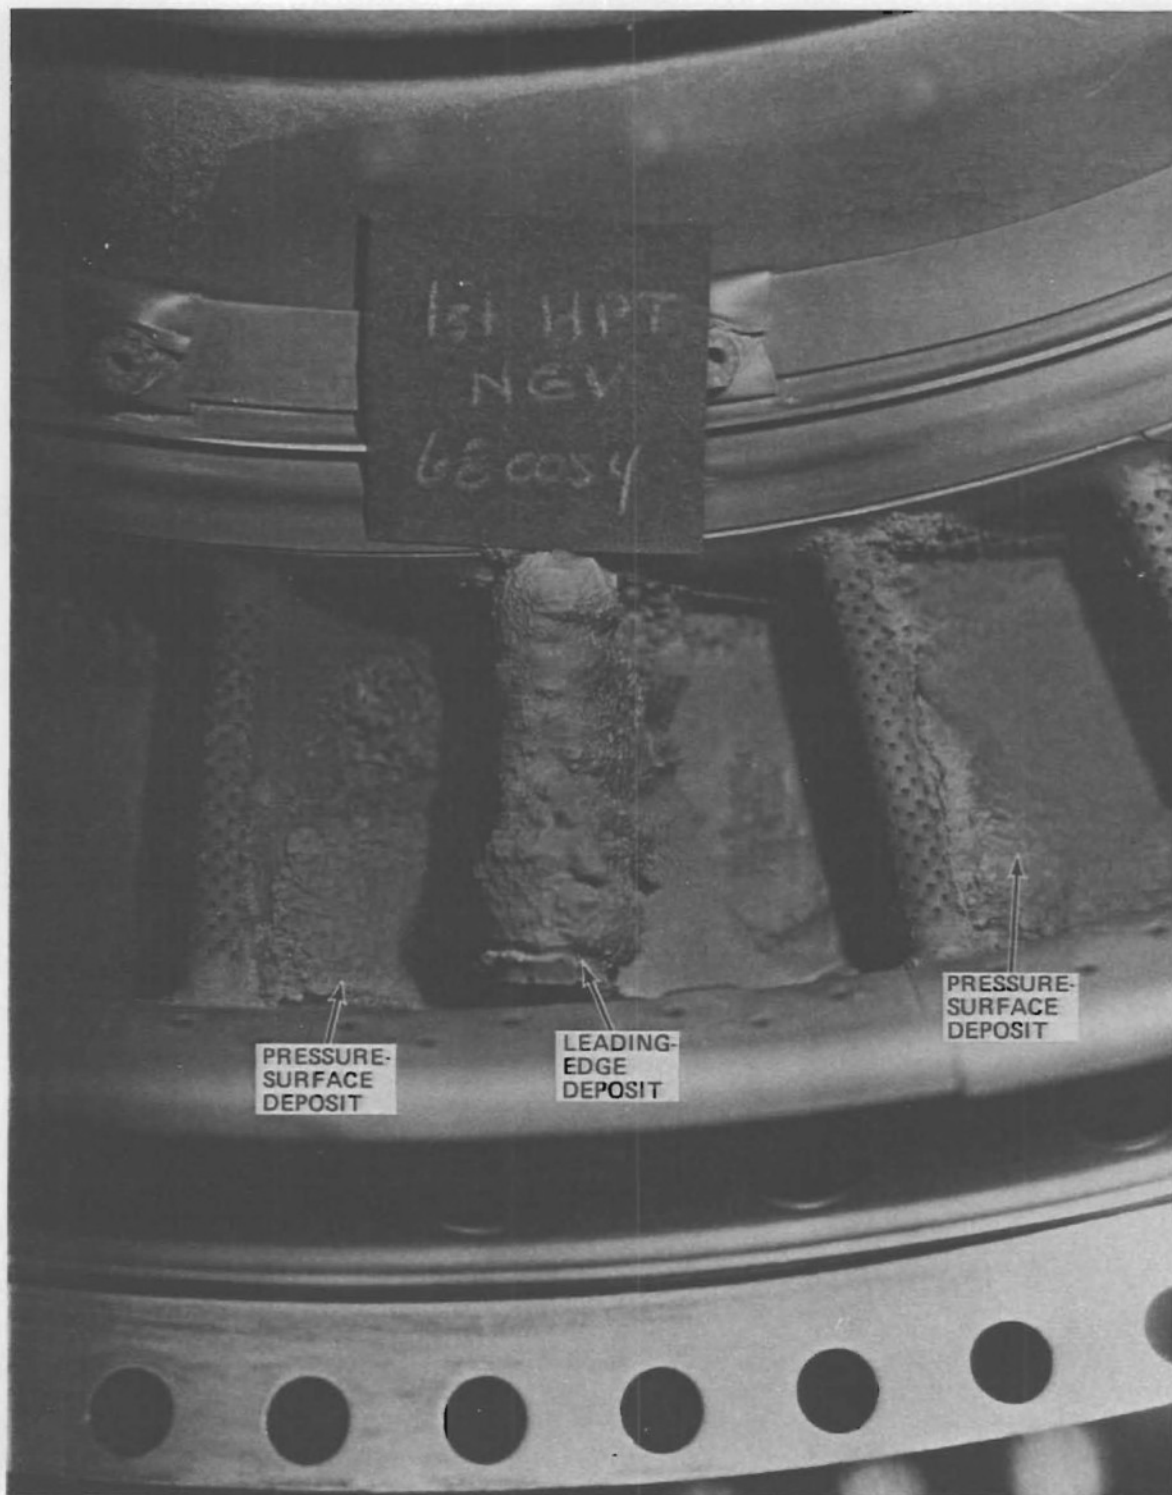
Figure 22. (U) Photograph of nozzle guide vane for first stage high-pressure turbine.

Figures 20, 21 and 22 are photographs taken of different portions of the high-pressure turbine first stage nozzle guide vane. Figure 20 illustrates the large deposit completely covering the vane leading edge. The cooling holes near the inner hub appear to still be open. However, beyond midspan the holes are blocked. Very heavy deposits on the vane pressure surface can be seen on two of the vanes shown in this photograph. One of the vanes is free of deposits, but the flakes remaining on the

surface suggest that there was a deposit there, but it had been blown away. The vane to the far left of the photograph is one for which the leading edge deposit and a portion of the pressure surface deposit have been blown away. A large quantity of this deposit that we claim has been blown away was recovered from the combustor liner. Photographs of the material taken from the combustor liner will be shown later to demonstrate that they, in fact, came from the guide vane shown in Figures 20 to 22.

The heavy deposits on the nozzle guide vane of the first stage of the high-pressure turbine are felt to have caused the rapidly increasing burner pressure and compressor discharge pressure that were illustrated in Section 3.4. These deposits caused excessive blockage at the NGV causing the operating line to move dangerously close to the surge line. In attempting to clear the deposits on the third purge attempt, the capability of the machine to operate normally was exceeded and the uncontrollable surge described in Section 3.5 resulted.

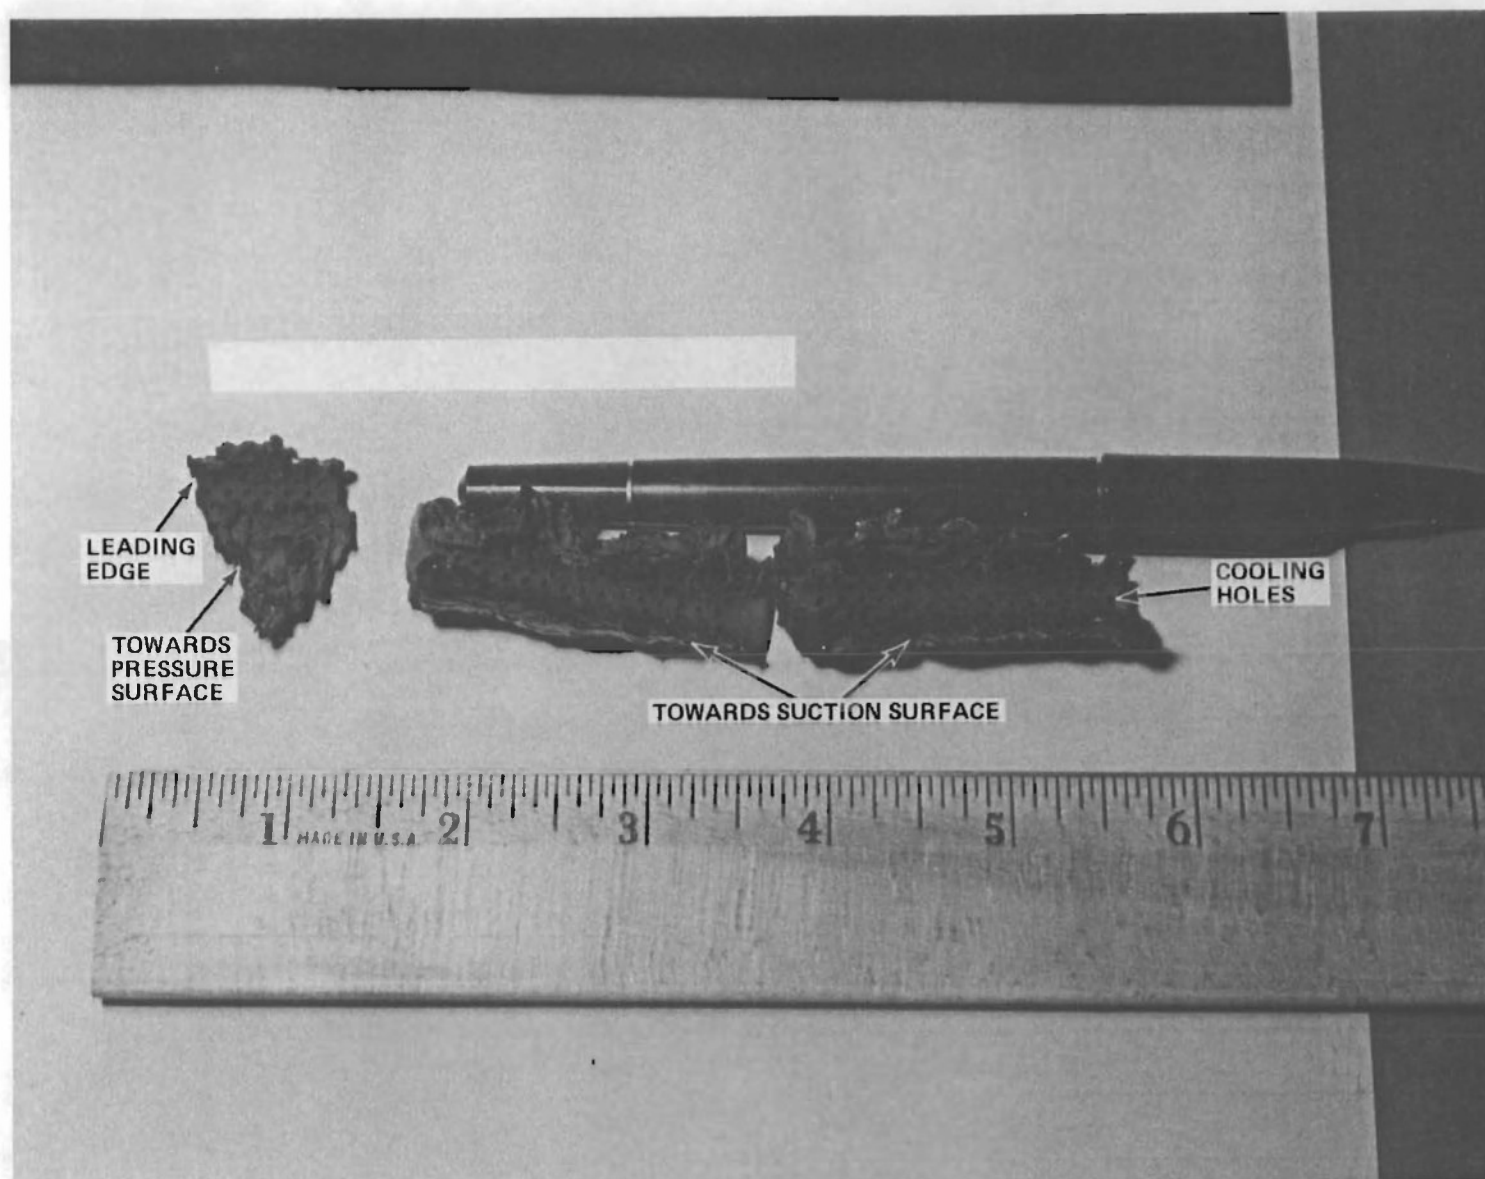
Figure 24 is a photograph of a portion of this loose material that fell out of the combustor liner at disassembly. Many of the pieces shown in this photograph can be identified as having come from the vane leading edge, the vane pressure surface, and the combustor liner wall. Figure 25 is a close-up photograph of several of these pieces that came from the vane leading edge. When these pieces were held up to the

Figure 25. (U) Close-up photograph of pieces that came from NGV leading edge.

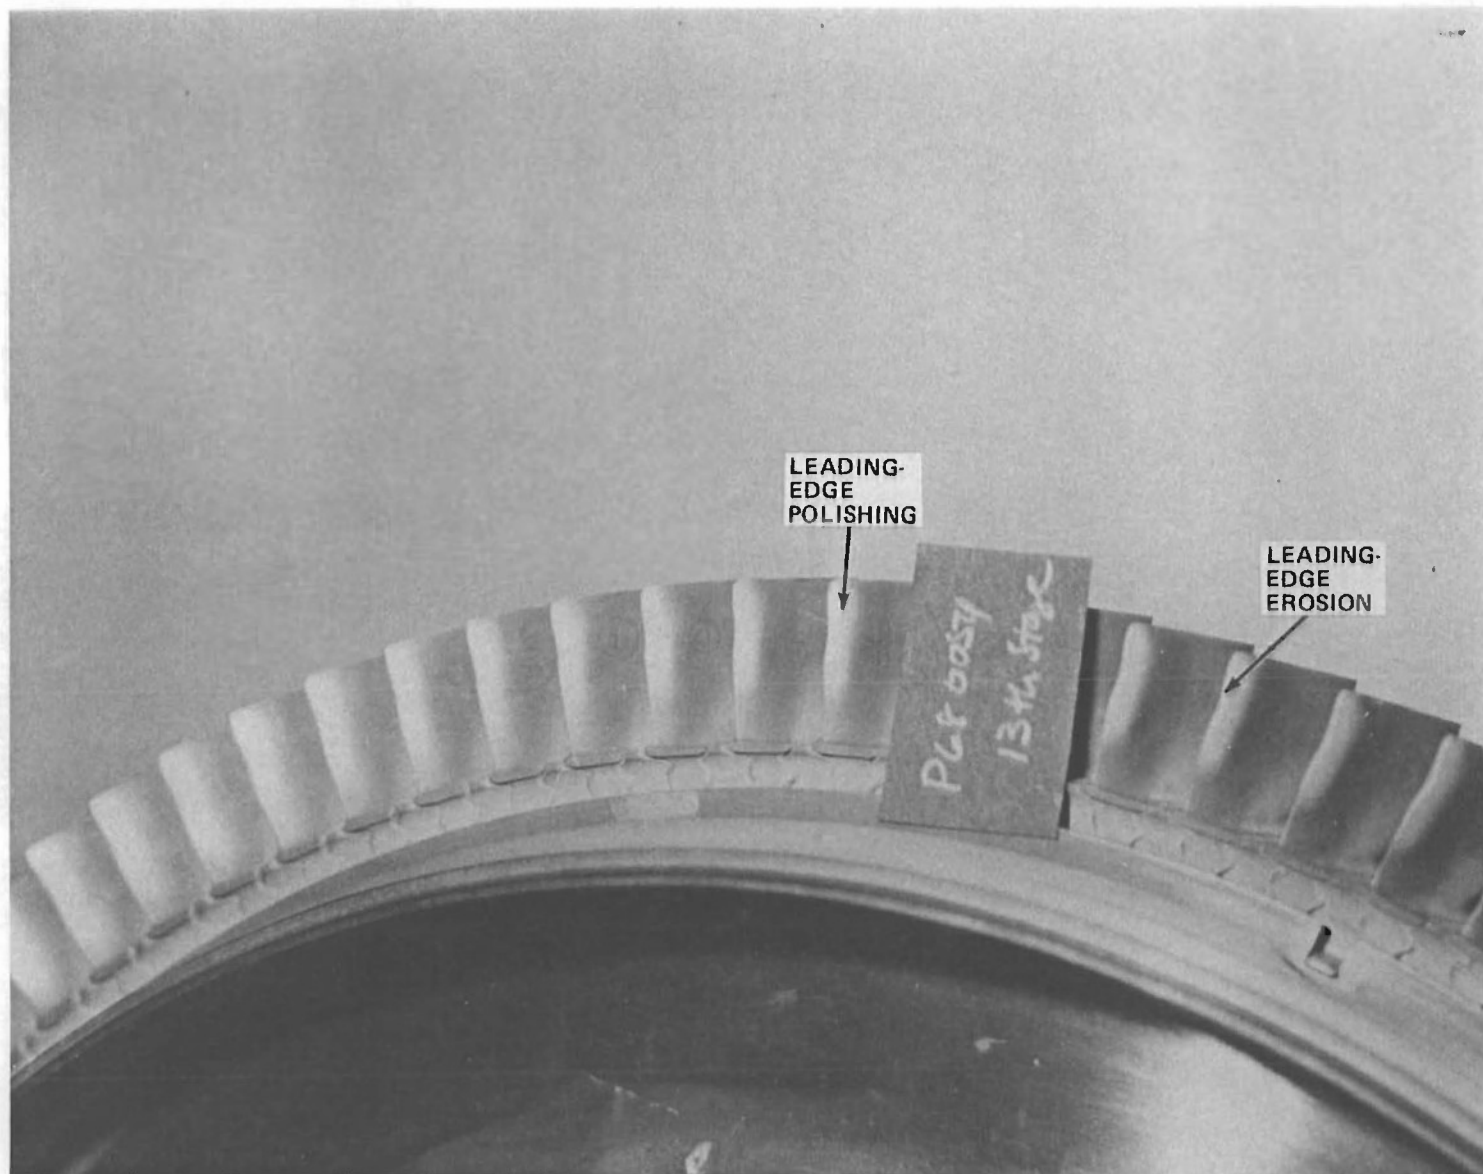
Figure 27 is a photograph of the 13th stage compressor rotor. The leading edge is highly polished and some material has been removed at about 70% span near the leading edge. The increase in tip clearance appears to have been mainly due to removal of the abradable shroud material as opposed to removal of material from the blade tip. The blade tips for this machine look much better than those of the machine described in Reference 1. By looking much better is meant that the tip has not been significantly thinned by material removal and that the profile has not been substantially changed by material removal. Figure 28 is a photograph of the 11th stage compressor blade tip which when compared to Figure 39 of Reference 1 illustrates the point just made.

Figure 27. (U) Photograph of 13th stage compressor rotor.

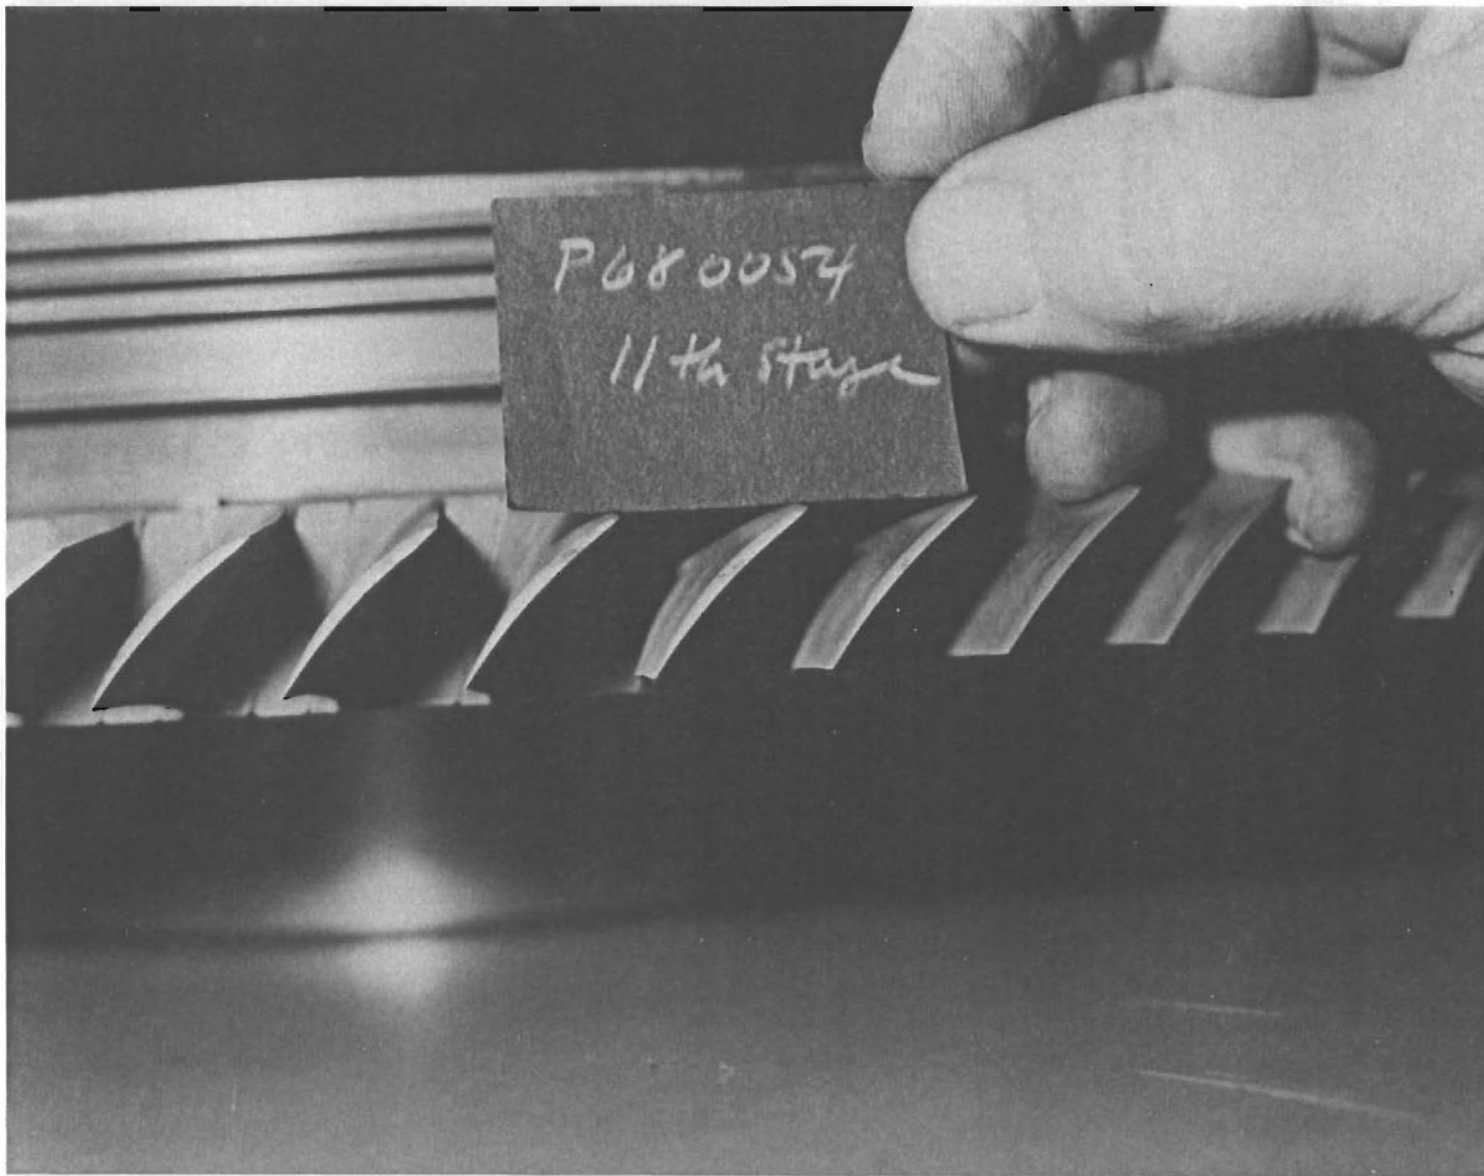
Figure 28. (U) Photograph of 11th stage compressor rotor blade tip region.
